Evaluating the linear behaviour of the historical Mehmed Pasha Sokolovic Bridge across the river Drina in Bosnia and Herzegovina

Halide Sert, Mutluhan Nas, Süheyla Yılmaz, Hakan Demirci, Ayşe Avşın, G. Sibel Turan, Nurdan Apaydın

Ministry of Transport, Maritime Affairs and Communications, General Directorate of Highways, Department of Structures, Division of Historical Bridges, Ankara, TURKEY.

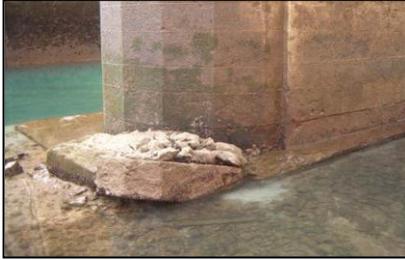
These deteriorations have burst into sight in the form of outcrop of the foundations a result of the fall of the original thalweg, the displacement due to the abrasion by water and the partial losses (See Figure 4). Also, floral deterioration and joint discharges were observed (See Figure 5).

Figure 4. Displacement in Foundation **Figure 5.** Joint Discharge and Vegetation

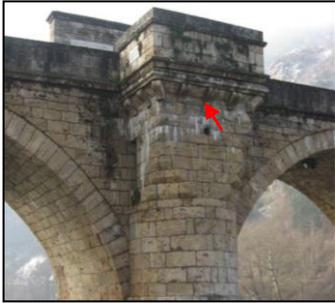
The water seeping from the bridge deck can both trigger the vegetation and lead to the disintegration of the mortar between the stones as a result of volume

expansion due to the freezing water and cause to the decomposition of the stones. The deteriorations caused by the seeping water are shown in Figures 6 and 7. [1]

Figure 6. Effect of the Seeping Water

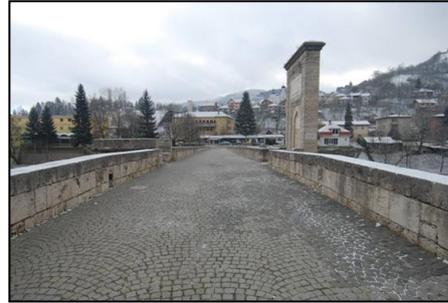
Figure 7. Water Seeping and Freezing into the Deck

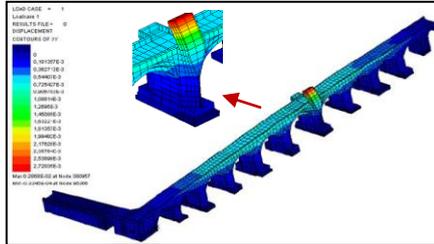
The analyses were first made for the damaged status of the bridge and for the post-restoration period using the LUSAS software and, a total of 11 analyses were performed for five load combinations. Accordingly, the hydrostatic force calculated considering the case where the water level rises above the bridge was applied onto the upstream surface as the compressive force, and was considered as $32,5 \text{ kN/m}^2$ from the foundation to the arch's stirrup level and as $26,25 \text{ kN/m}^2$ from the arch's stirrup level to the highest level. The displacement values based on the current status are shown in Figure 8 whereas the tensile stress values are given in Figure 9. The maximum displacement values were obtained in the section where the richly decorated stela is located and calculated as $2,87 \text{ mm}$. The highest tensile stress values were however obtained in the damaged foundation A6 on which the richly decorated stela is located and it was found to be $1,05 \text{ Mpa}$. For the post-restoration status, the displacement value of the same section was found to be $2,82 \text{ mm}$ and the tensile stress was found to be $0,98 \text{ Mpa}$ in A3, A4 and A8.

Figure 8. Pre-Rest. Displacement

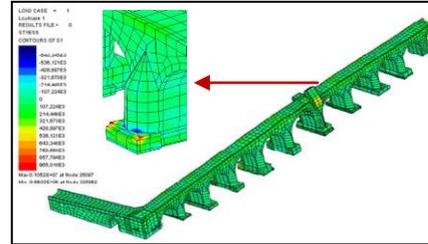
Figure 9. Pre-Rest. Tensile Stress

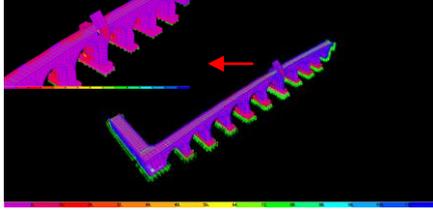
According to the results of the analysis for hydraulic load, the displacement occurred in the area shown in Figure 17 in the pre-restoration status, and the maximum value was found to be 2,72mm. The tensile stress, however, is shown in Figure 18 and found to be 1,043Mp. As a result of seismic analysis based on the design spectrum in the case of exposure to a 0.2g-accelerated motion, the highest tensile stresses occurred in the area where the richly decorated stela is located, and were obtained as 0.136 Mpa (Figure 19).

Figure 17. Displacement in Current Condition

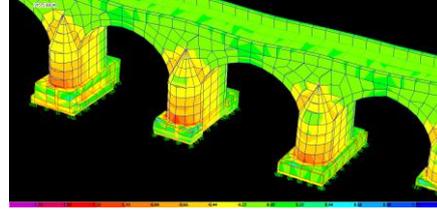
Figure 18. Tensile Stress in Current Condition

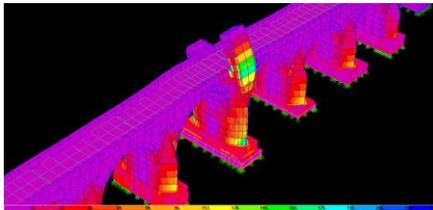
Figure 19. Pre-Restoration Tensile Stress

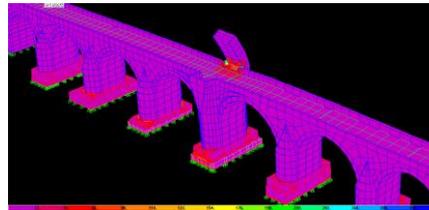
This value rises to 0.204 MPa in 0.3 g-accelerated analysis. The compressive stress however was found to be a maximum of 0,227Mpa and obtained as 0,341Mpa for an earthquake of 0,3 g acceleration (Figure 20). [10]

Figure 20. Pre-Restoration Compressive Stress
