Structural Investigations on Justinianus Bridge in Sakarya City of Turkey

Vildan G. Mentese¹, Yasar H. Gedik¹, Oguz Gunes², Kasim A. Korkmaz²

¹Istanbul Technical University, Department of Architecture, Taskisla, Istanbul, Turkey

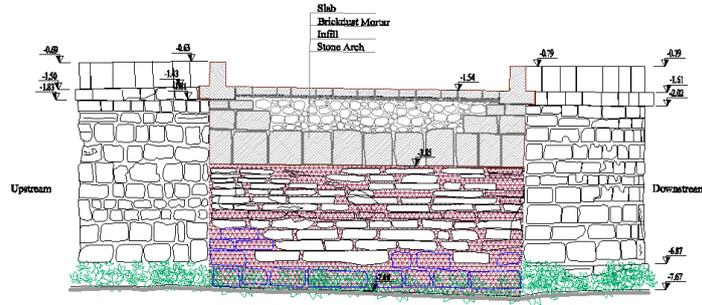
Fig.6. Cross section of the arch numbered 7 [9]

Masonry units of the bridge are mostly made of limestone blocks. Rubble masonry blocks with brick dust mortar were used as backfill material in between exterior spandrel walls (See Figure 6). A part of the slab at the north side of the bridge is determined as concrete according to survey project prepared by General Directorate of Highways that likely attached to the bridge during a past restoration.

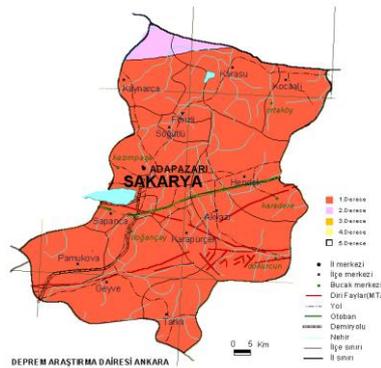
Fig.7. Seismic Zoning Map of Sakarya, Turkey [10]

The bridge is located on near the Northern Anatolia fault zone and is it is classified as the 1st degree seismic zone (See Figure 7) according to Seismic Zone Map of Turkey [11]. Geotechnical survey reports supplied by General Directorate of Highways shows that the soil group is determined as group C; and Local Site Class of the bridge is defined as Z3 class correspondingly, according to current Turkish Seismic Code released in 2007 named “Specifications for Buildings to be built in Seismic Zones”.

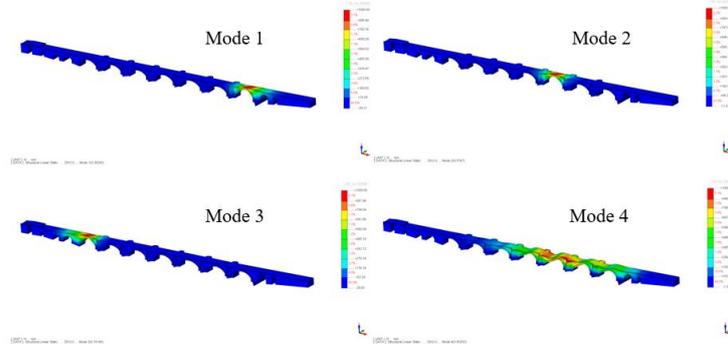
Fig.10. Mode Shapes

To determine modal characteristics and behavior, free vibration analyses were carried out. The first free vibration period of the bridge is $T_1=0.121$ sec. It is a small value, since the structural stiffness is quiet significant. The periods for higher modes 2 to 5 are $T_2=0.117$ sec, $T_3=0.114$ sec, $T_4=0.113$ sec and $T_5=0.112$ sec (See Table 3). Mode shapes of 1st, 2nd, 3rd and 4th modes are given in Figure 10. In mode shapes, responses localize on single arches in the first three modes. In the 4th mode, response expanded through longer spans with a mix of transverse and torsional behavior.

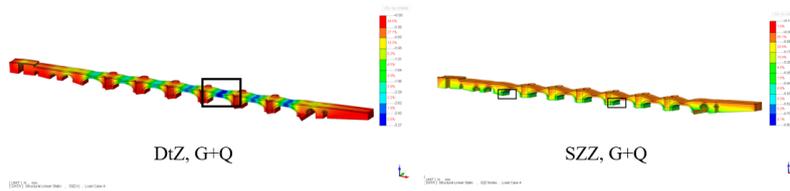
Fig.11. Vertical Displacement (DtZ) & SZZ Stress Distribution under G+Q Load Combination

Maximum vertical displacement (DtZ) under G+Q loading was obtained as 3.0mm near keystone level of the A8, has the largest span. Maximum compression stresses occurred around the piers under self-weight as expected, maximum vertical normal stress (σ_{zz}) under G+Q loading reaches up to 0.8MPa in compression on the piers of arch A8. Tensile stresses were mainly localized about 0.10MPa near keystone level of the arches and flood splitters (See Figure 11).

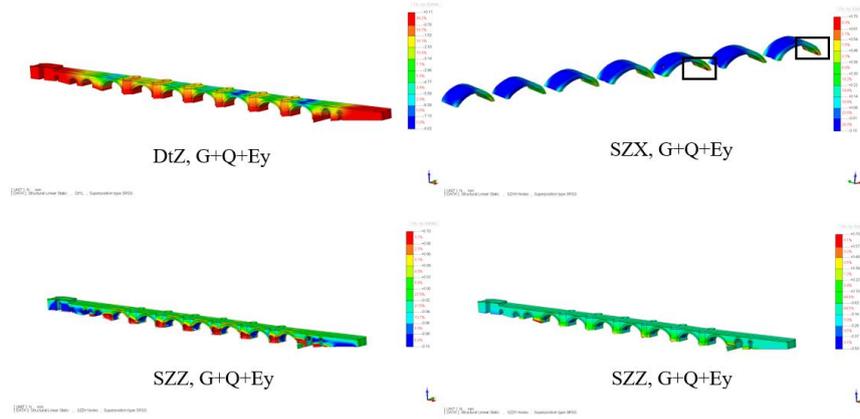
Fig.12. Vertical Displacement (DtZ) & Stress Distributions Under G+Q+Ey Load Combination

Under G+Q+E_y load combination including seismic loads along transverse Y direction, the maximum vertical displacement, DtZ was determined as 7mm near keystone level of A8 which has the largest span. The displacement values in Y direction (DtY) were determined as 8mm in the same arch. Maximum compression stress of 0.70MPa was determined on the piers of arch A8. The maximum tension stress of 1.2MPa was determined on spandrel around arch A3 and A4. Moreover, the highest tension values mostly localized around flood splitters attached piers (See Figure 12). In case of shear stress, the maximum value reaches about 0.8 Mpa for SZX were defined on arches with longer spans. Since the maximum values generally localized at a unique point or a limited area, discussion on the average distribution was also made. That shows the highest values having a meaning-

ful area rather than a very local distribution. In this sense, maximums are around 0.5Mpa for compression and 0.4MPa for shear stresses.
