Evaluating the linear behaviour of the historical Mehmed Pasha Sokolovic Bridge across the river Drina in Bosnia and Herzegovina

Halide Sert, Mutluhan Nas, Süheyla Yılmaz, Hakan Demirci, Ayşe Avşın, G. Sibel Turan, Nurdan Apaydın

Ministry of Transport, Maritime Affairs and Communications, General Directorate of Highways, Department of Structures, Division of Historical Bridges, Ankara, TURKEY.

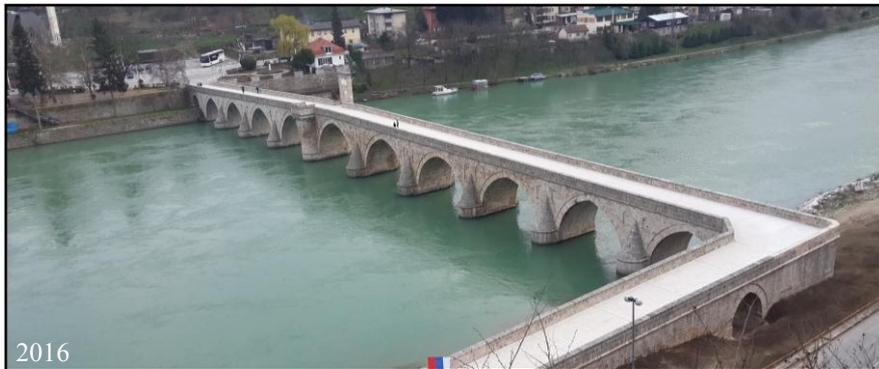
Figure 1. View of Downstream after Restoration

In 2003, the bridge was closed to vehicle traffic and, then, was included in the UNESCO's World Heritage List in 2007. Pursuant to the protocol signed between the Turkish International Cooperation and Development Agency (TIKA) on behalf of Turkey and the Commission to Preserve National Monuments on behalf of Bosnia and Herzegovina, the “Restoration Project and Implementation” of the bridge was undertaken by Turkey whereas the consulting and supervision services were undertaken by the General Directorate of Highways on behalf of TIKA, and the Restoration Implementation Projects of the bridge were achieved in 2010 and its restoration was completed as of the current year (Figure 1). [1]

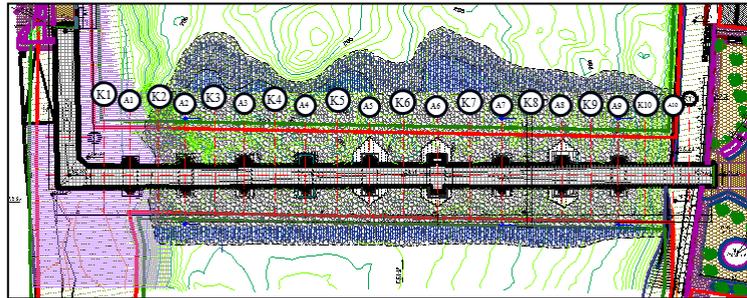
Figure 2. Restoration Layout Plan

In the World War I, the abutments A3-A4 and the arches K3, K4 and K5 were demolished, the disappeared parts of the bridge were reconstructed in 1939, and in the World War II, the abutments A3, A4, A5, A6 and the arches K4, K5, K6 were completely and the arches K3, K7 were partially demolished, the richly decorated stela and the sofa were destroyed, the reconstruction of the demolished parts was started in 1949 and, instead of mortared rubble, concrete was used for the interior parts of the abutments. A new repair was performed on the foundations of abutments by M. Gojkovic in 1980-81; steel sheet piles were formed around the foundations of abutments A5, A6 and A8 and a concrete jacketing was applied in between (See Figure 2).
